Immingham Jetty Inspection

Frankham were appointed to carry out a structural inspection on a jetty on the River Humber

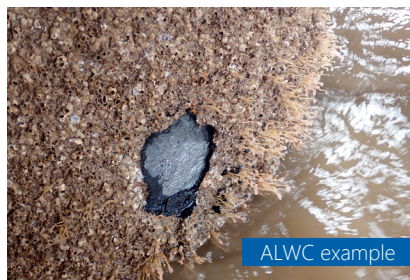
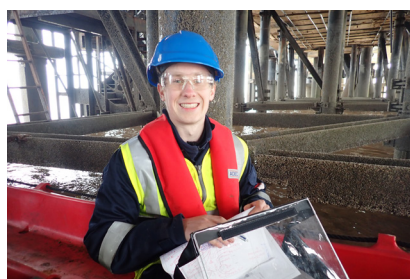
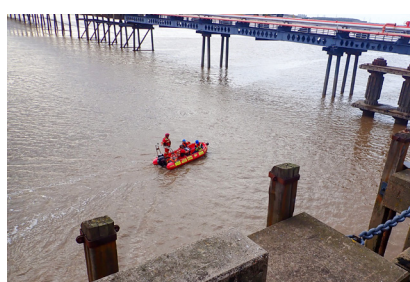
Our engineers discovered accelerated low water corrosion (ALWC) or microbially influenced corrosion (MIC) on some steel piles during inspections. ALWC is a lesser known phenomenon which can cause catastrophic damage if left unchecked. Frankham takes the opportunity to raise awareness of this defect where we can.

ALWC is an aggressive form of corrosion caused by bacteria that can severely impact structural integrity of marine infrastructure. It can be found in unprotected areas of tidal waters and is typically found at the lowest astronomical tide level and below, hence the long-winded name.

1.5 mm loss of steel per annum has been recorded in some extreme cases which could prove to be catastrophic for structures that have thin walled steel such as sheet piled walls. However, 0.3-1mm per annum is considered typical, which is still a significant loss. Damage and loss of section is typically localised and will appear in discrete spots which can be plate repaired.

MIC is best identified by visual inspection; giveaway signs include bright orange corrosion over a black film material which if you scrape away will reveal shiny pitted steel beneath as pictured. Spotting these tell-tale signs can be difficult as they are sometimes obstructed by marine growth, so it's important to remove as much marine growth as possible during inspections.

Remedial strategies are driven by the extent of damage caused. Low damaged areas can be protected by cathodic protection systems or coating whereas highly damaged areas may require local plate repairs in addition to protection.
