# Stone Crossing Station

Stone Crossing Station is one of the maintenance and engineering projects managed by Network Rail, in accordance with the £4.8 billion Levelling Up Fund.

The purpose of the commission, in Stage 1, was to assess the condition of the DOO monitor blockwork and mass concrete foundation. Stage 2 was to design permanent works to support the DOO platform by means of raking props and shallow strip foundation at the base of the embankment.

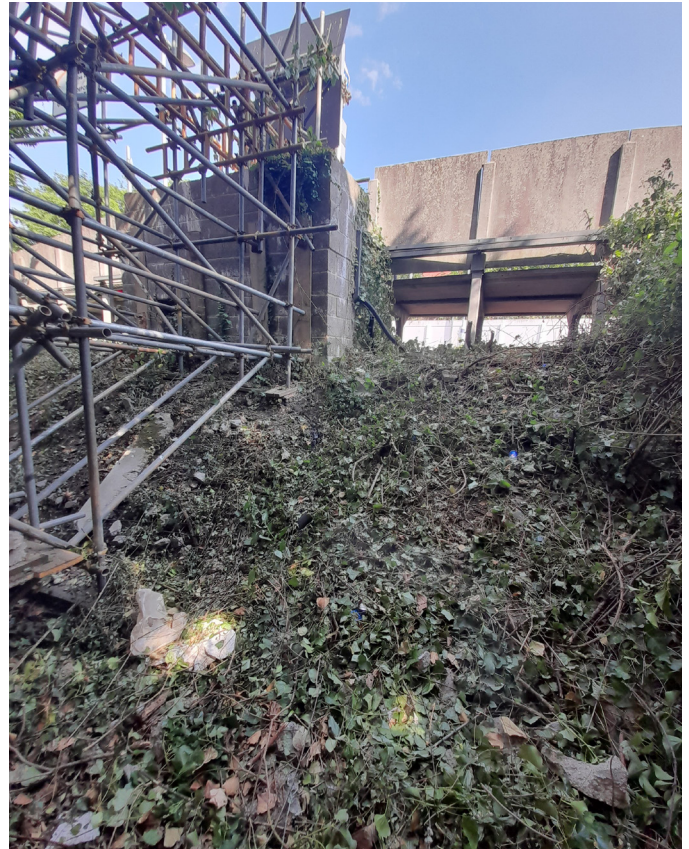
- Lack of record drawings and quality of collected data – detailed and qualitative surveying of the existing assets to observe defects and understand what caused them. This was of importance to provide the right set of recommendations to maintain and, if possible, improve the structural performance of the existing blockwork and mass concrete foundation supporting the DOO Monitor.
- Restricted access for the survey – access to the outside face of the High Mileage wall was not possible due to the steepness of the embankment.
- Props – potential for deflection of the props and not properly tightened fixings which would cause further deterioration when loading the remedial works.
- Foundation deflection – potential for deflection and settlement of the shallow strip foundation, causing further displacement of the DOO platform.

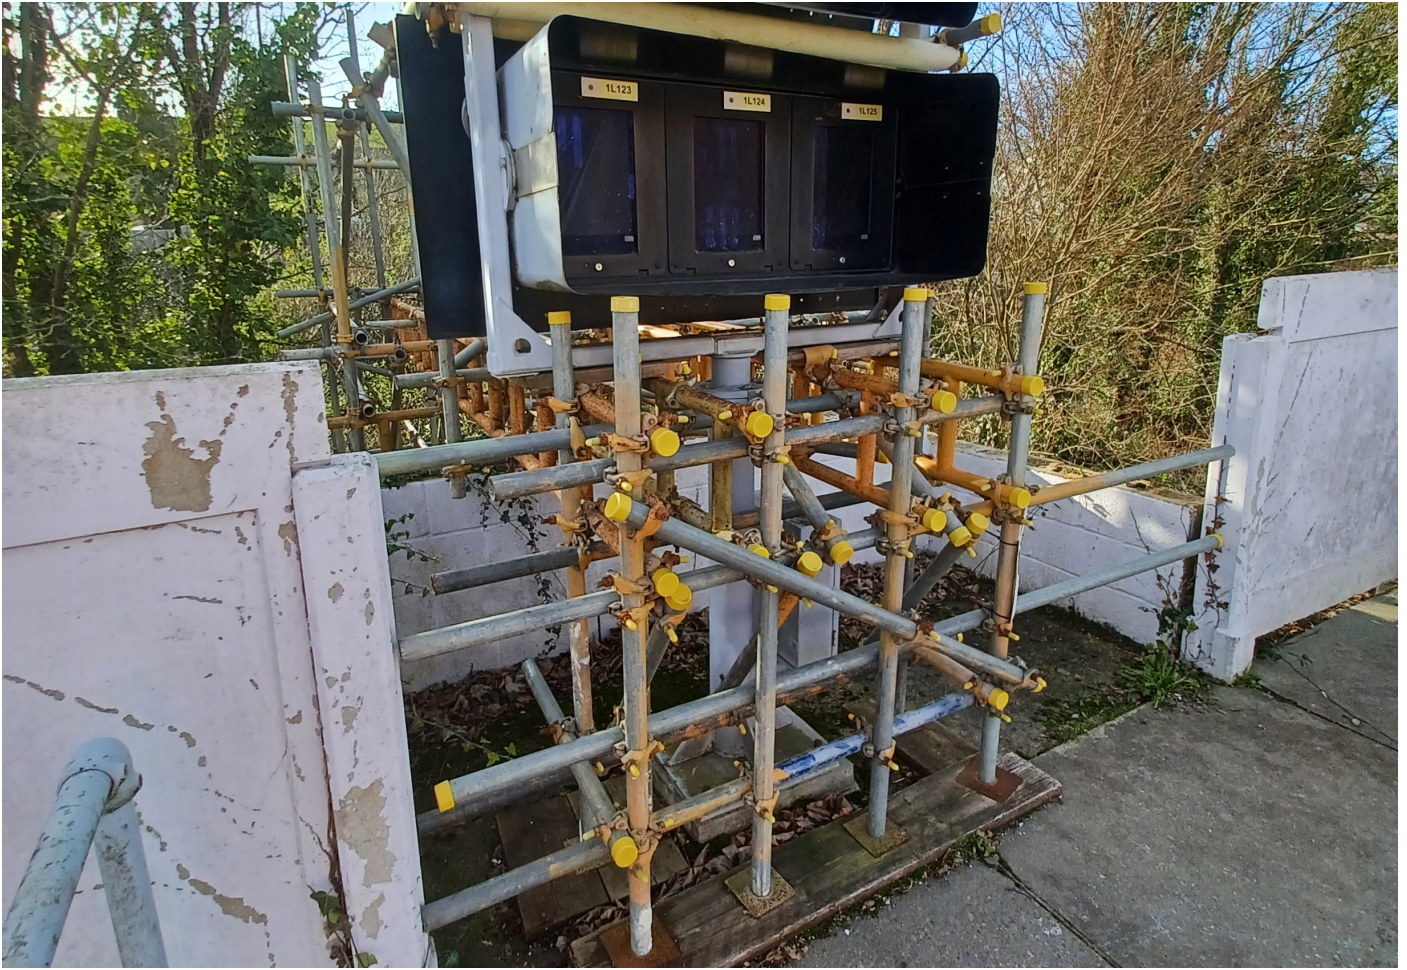
The inspection revealed that the part of the DOO foundation closer to the platform had not sunk significantly, whilst the part further from the platform, and closer to the crest of the embankment, appeared to have sunk, leading to rotation of the entire block. This was most clearly observed where the side walls of the block have moved away from the platform back wall posts, which are monolithic with the platform trestles.

To overcome this structural instability and improve the structural integrity of the DOO platform, remedial works were designed, and installation method specified, to prevent further rotation of the DOO platform.
